**DEPARTMENT OF CONSERVATION**

DIVISION OF MINES AND GEOLOGY

February 27, 1998

RE: ENGINEERING GEOLOGIC REVIEW OF RIO NIDO LANDSLIDE, SONOMA  
COUNTY, CALIFORNIA

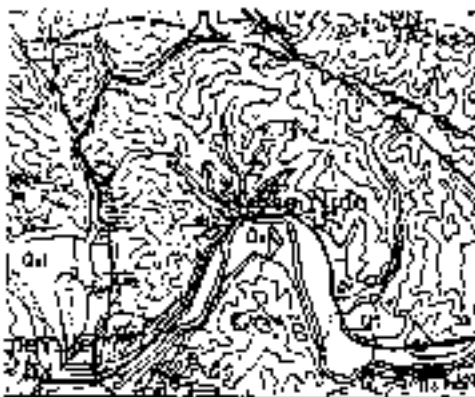
Figure 3. Geologic map of Pine Ridge Landslide and vicinity. After Salasaga Landslide (Huffman and Armstrong, 1992).

The Rio Nido area is underlain by interbedded sandstone and shale of the Rio Nido Terrane of the Franciscan Complex, Geologic Map symbol KJfss mapped by Huffman and Armstrong (1980) and Blake and others (1984) (see Figure 3 Geologic Map of the Rio Nido Landslide and Vicinity). The Rio Nido Terrane outcrops along the Russian River near Rio Nido and to the north as several deformed but relatively unmetamorphosed, sandstone-rich, fault-bounded belts of broken formation. In the vicinity of the landslide, these units strike generally east-west and dip 37 to 48 degrees to the north. Ridge lines near the landslide are generally stair stepped, consisting of alternating gently and more steeply sloping reaches. The sandstones generally underlie the steeper sloping portions of the ridges and the shales underlie the more gently sloping portions.

The sandstones and shales are red-brown, thick to thin bedded, intensely weathered, moderately weak, very intensely fractured and friable. Drainages underlain by the Franciscan Complex commonly accumulate loose and weak soil-like colluvium of varying thicknesses. The soils in the landslide vicinity have been mapped as the Hugo-Josephine complex soil series consisting of Hugo very gravelly loam and Josephine loam (Miller, 1972).

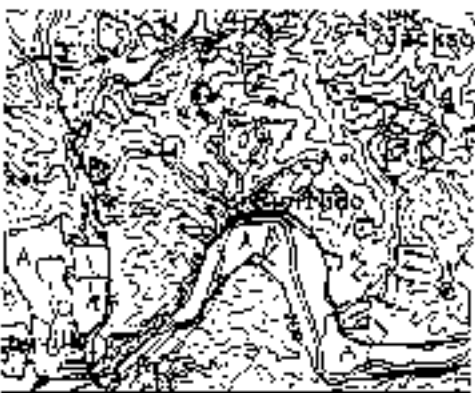
Figure 4. Mescal Landslide and Relative Rock Stability Categories of Rio Hato Landslide and vicinity (Huffman and Armstrong, 1992).

The drainage in which the landslide occurred was mapped by Huffman and Armstrong (1980) as containing an existing landslide, as were many of the other

drainages in the Rio Nido area (see Figure 4, Landslide and Relative Slope Stability Categories of the Rio Nido Landslide and Vicinity). Most of the mountainous terrain in the vicinity of the landslide has been mapped as Relative Slope Stability Category "C", described as "Areas of relatively unstable rock and soil units, on slopes greater than 15%, containing abundant landslides". The Franciscan Complex, in general, consists of relatively weak, broken rock. Areas underlain by these rocks and the accumulated colluvium are considered to be relatively unstable and contain abundant landslides.

- 6) Existing landslides have been mapped throughout Rio Nido and the vicinity and additional landslides may occur in other canyons of this area because rainfall and the geologic material are similar throughout the region.

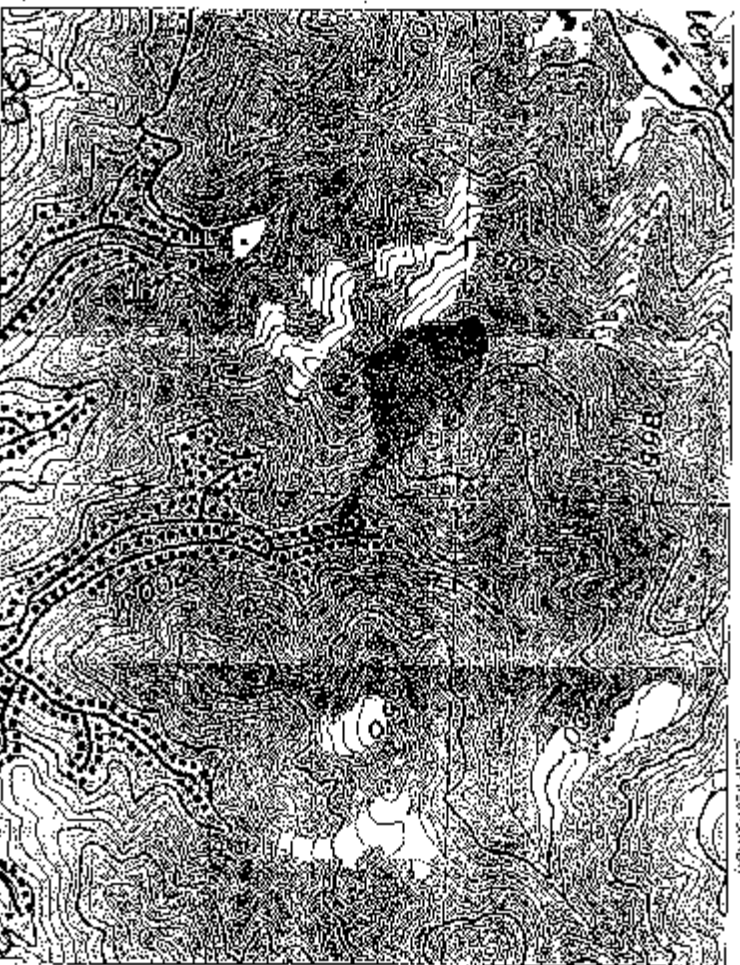
# Rio Nido Landslide

The Rio Nido landslide is in a complex landslide, consisting of a rotational slump near the top of the ridge at an approximate elevation of 720 feet, and debris flows originating from the disaggregating toe of the rotational block. The debris flows moved downslope through a narrow drainage and ponded debris on the canyon floor, at an elevation of approximately 120 feet, destroying three homes and damaging four others. The total elevation drop of the landslide mass is about 600 feet (see Figure 2, Map of the Rio Nido Landslide). The vicinity of the landslide is heavily wooded with mature bay and Douglas fir trees with no indications of recent timber harvesting, grading or construction. No Timber Harvest Plans covering the landslide vicinity have been filed with the California Department of Forestry and Fire Protection (CDF) for the last 20 years. One Exemption was filed to remove one tree from the canyon floor (Tom Spittler, pers. comm.) but this would have no effect on slope stability.

Total width of the landslide headscarp is about 600 feet. The headscarp is arcuate in shape and was estimated to be about 30 feet high near its center during the February 8 field reconnaissance. The headscarp diminishes in height toward the north and south, until it disappears at the margins of the landslide. The bedrock material exposed in the headscarp consisted of intensely fractured and weathered sandstone typical of the Franciscan Complex.

Directly below the headscarp the rotational block has dropped (slumped) about 30 feet down the headscarp. This block has rotated down and to the east (displaced out of the slope) and tilted backwards, so the surface of the block now slopes slightly back into the slope. The rotational block varies between 100 and 200 feet in width. The field team was not able to ascertain the precise downslope extent of the rotational failure, but the thickness of the rotational block was estimated to be about 50 to 100 feet. Therefore the base of the rotational block is estimated to be at an elevation of about 600 to 650 feet. The rotational block has broken into a number of smaller blocks, especially near the eastern edge of the block. Each of the smaller blocks is separated from adjacent blocks by a scarp and/or grabens that trend roughly parallel to the headscarp or outward edge of the larger rotational block. The displacement on the

scarps and grabens are generally between a few inches and 4 feet at the time of the February 8 and 11 reconnaissance. Repeated reconnaissance of the rotational block conducted by Mays indicates the block has continued to break up, with displacements on the scarps and graben increasing and small failures occurring from the outside edge of the rotational block. This rotational block also has a dense canopy of trees, many of which are now tilting in various directions and leaning against each other as a result of the breakup of the larger block. Surface water is ponding on the rotational block directly below the headscarp.

The debris flow source areas are on the eastern, displaced edge of the rotational block where the slope materials disaggregated and failed, flowing downslope to the canyon floor. The debris flow moved down two drainages. The southern, larger debris flow destroyed three homes and damaged four others on the west side of the canyon floor and deposited debris across to the east side of the canyon. The debris fan diverted the unnamed creek that flows down Upper Canyon Three to the east. During the February 8 and 11 reconnaissance, the creek was flowing in several new channels across the debris fan. Relatively clear surface water was observed flowing from springs in the debris flow source areas, becoming increasingly muddy as it flowed down the margins of this debris flow.

The smaller, northern debris flow moved directly east from the source areas down a shallow drainage, but did not reach the canyon floor. Muddy water was flowing from springs in the source area of the northern flow, down the drainage, and into the unnamed creek in Canyon Three.

The Rio Nido Landslide is a complex landslide consisting of a rotational slump with debris flows that originated from the toe of the rotational slump and flowed down two drainages. It is estimated that the rotational block is about 50 to 100 feet thick. The estimated volume of the rotational block is about 140,000 to 250,000 cubic yards (yds) and the estimated volume of the material deposited on the canyon floor is about 20,000 to 30,000 yds. The southern debris flow mobilized and flowed down to the canyon floor, destroyed three homes and damaged four others, deposited a debris fan and diverted the creek. The northern debris flow moved eastward but did not reach the canyon floor. The cause of the landslide is interpreted to be the prolonged and intense rainfall in the Rio Nido area prior to the failure, falling on steep slopes with high relief, in an area underlain by relatively weak landslide prone rock, where landslides have occurred in the past. This rainfall has saturated the rock and colluvial material, reducing the material's strength and increasing its weight, until the material failed.

- 8) The rotational block will have to be mitigated to provide long term slope stability. Mitigation will likely include removal of the rotational block, and recontouring and revegetation of the slope.

- 6) No large scale mitigation work should be conducted on the landslide until the rotational block has drained and movement of the block has stopped. The consulting engineering geologist should decide when it is safe to begin work on stabilizing the landslide.
